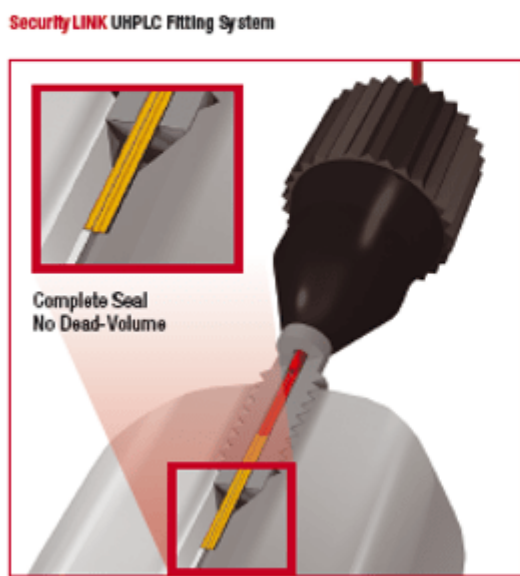
Figure 1: Incorrectly Swedged for Column showing Inlet Depth
